A BRAZING PROCESS FOR Cb-1Zr HEAT RECEIVER TUBES

Prepared under Contract No. NAS3-10603 by
SOLAR DIVISION, INTERNATIONAL HARVESTER COMPANY
San Diego, Calif.

for Lewis Research Center

NATIONAL AERONAUTICS AND SPACE ADMINISTRATION

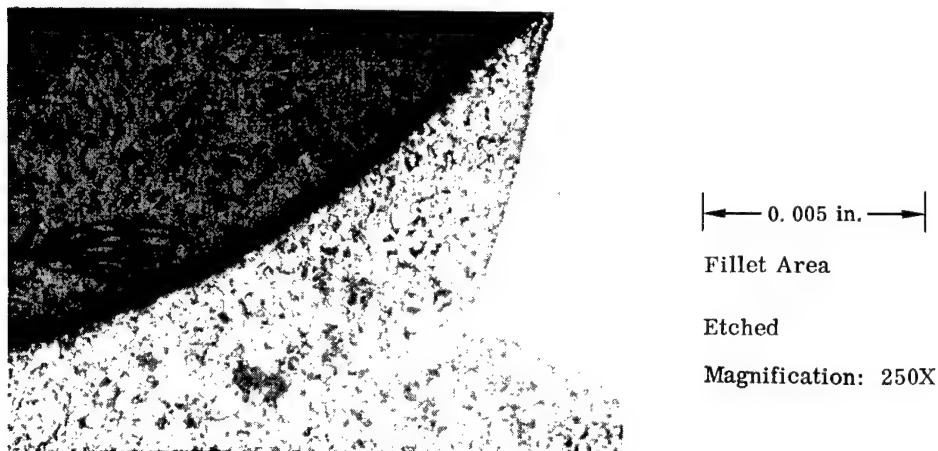
FIGURE 13. Cb-1Zr T-JOINT BRAZED WITH Zr-28V-16Ti; As-Brazed Condition

The beryllium-free alloy, Zr-28V-16Ti, exhibited good brazing performance at 2200°F. Some minor sluggishness of flow was the only problem noted; no erosion tendency was observed (Fig. 13) and good bend toughness was indicated. Also of importance, this alloy and its brazements possessed the lowest hardness ($\sim R_C 35$) among all of the Zr- and Ti/Zr-base candidate braze alloys screened (Table II). The moderate hardness level indicated a good potential for the alloy to be rolled into foil or wire forms.

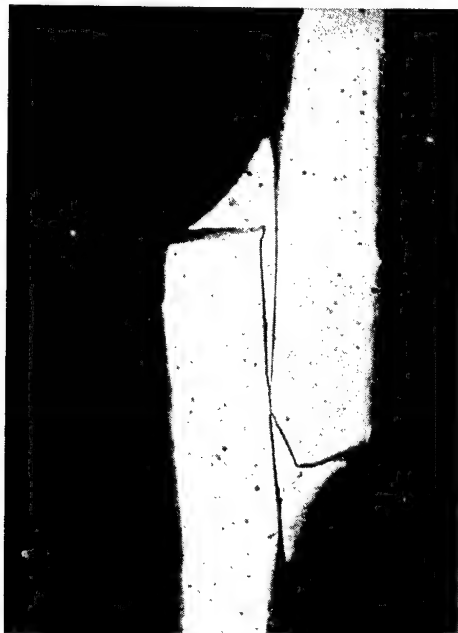
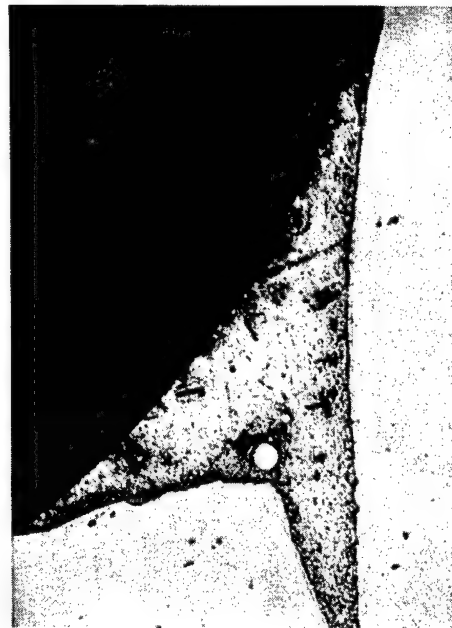
FIGURE 21. LAP-JOINT BRAZEMENTS OF Cu-2Ni BRAZE ALLOY

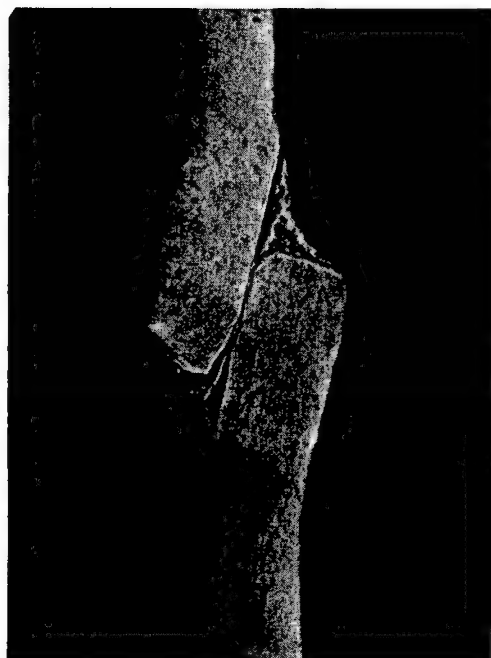
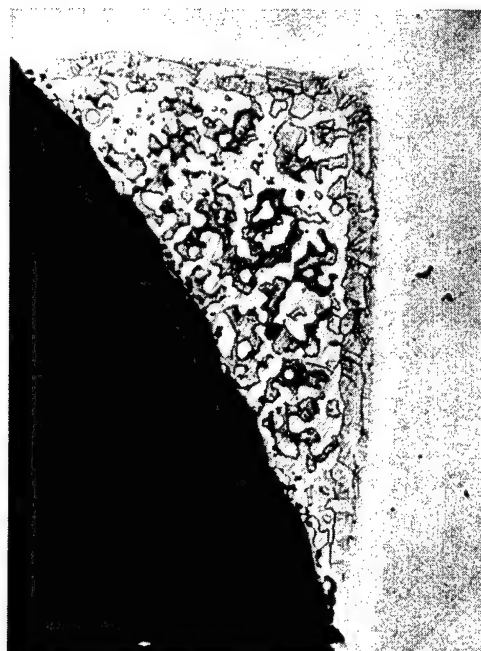
FIGURE 22. LAP-JOINT BRAZEMENTS OF Zr-28V-16Ti BRAZE ALLOY

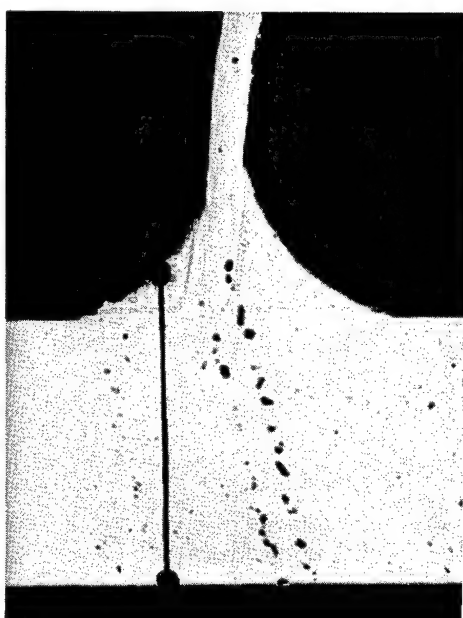
FIGURE 24. BRAZED T-JOINT SPECIMENS FOR MICROPROBE ANALYSIS;
Zr-28V-16Ti Braze Alloy

To assess the degree of interdiffusion of the braze alloy and Cb-1Zr sheet, as another indication of thermal stability at 1750° F, a series of electron microprobe analyses were conducted on the as-brazed and the aged T-joint specimens shown in Figures 24 through 26. A line traverse with a one-micron diameter beam was made across the 0.025 inch thickness dimension (horizontal member) of each Cb-1Zr T-joint, directly under the braze fillet, which then was continued 0.005 to 0.006 inch into the braze fillet region. The traverse on each specimen was initiated at the bottom or exterior edge of the horizontal Cb-1Zr member (Point O of Fig. 24 through 26). The
